**Flood Control Project Maintenance
Levee Inspections**
LMA District Cover Sheet
Spring 2017 Levee Inspection Results

Sutter Maintenance Yard East Levee Sacramento River

Spring 2017 Levee Inspection Results

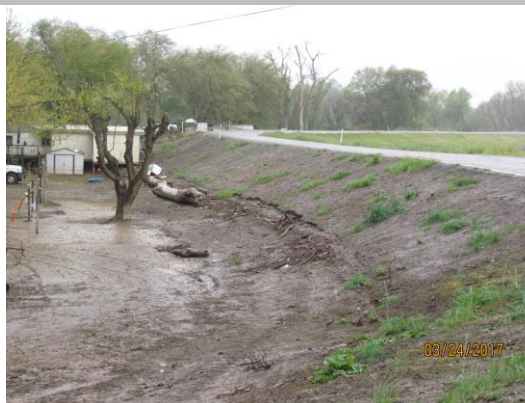
Photo 1 of 1 : SP_2017_ST0003_264_130_20170329_00180.jpg

LM Start	0.11	Rating **	M	Issue No.	130
LM End	0.14	Issue Type +	Ma	Location *	WS
Category	Earthen Levee			GPS Latitude/Longitude	
				Start	End
Item	Slope Stability			39.195163 °	39.195038 °
				-121.936815 °	-121.937435 °
DWR ID	DWR_ST0003_01_s_2017_130				
Comment Code					
S1 : Repair slope instability.					
Inspector Comment					
Repair the erosion along the waterside slope.

View of the erosion along the waterside slope.

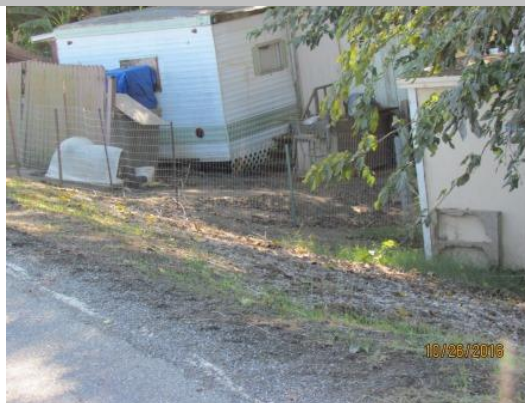
Photo 1 of 1 : SP_2017_ST0003_264_3_20170315_00003.jpg

LM Start	0.15	Rating **	U	Issue No.	3
LM End	0.20	Issue Type +	En	Location *	WS
Category	Earthen Levee			GPS Latitude/Longitude	
				Start	End
Item	Encroachments			39.194978 °	39.195022 °
				-121.937502 °	-121.938563 °
DWR ID	DWR_ST0003_01_s_2012_3				
Comment Code					
BU : Building					
Inspector Comment

View of the trailers and building on the waterside.

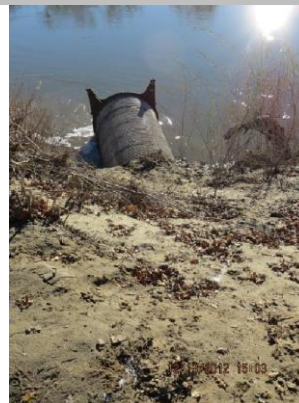
Photo 2 of 3 : UCIP_SP_2017_51650_46960.jpg

Item	DWR UCIP LMA Responsibility			39.197028 °	39.197028 °	
				-121.943597 °	-121.943597 °	
DWR ID						
Comment Code						
Inspector Comment						
FS_ID:51650						
DS_ID:17307						
EP_NO: 9534						
Repair Type: No Action Needed						
Crossing Status: Found						
UCIP Comments: 4/24/2017 Both sides of crossing were underwater during site visit. Will need to revisit after water levels drop. (DWR Sutter Yard- A Freitag)11/7/2016 Crossing appears to be in good condition. (DWR Sutter Yard- A Freitag)6/6/2016 Crossing appears to be in good condition.4/6/2015 Good Condition. No issues. Semi circle CMP half riser in inlet structure on LS. Inlet opeing has no trash rack, this may cause safety issue.6/30/2014 Same as last inspection.12/30/2013 Same as last inspection.7/29/2013 Same as last inspection.						
FIELD_STRUCT_DESC: [Butte Slough Drainage Structure] 78-inch drainage pipe of an unknown material through the levee, 3 feet below the crown. Flap gate on the waterside (WS). Corrugated metal pipe (CMP) half riser (in a semi-circle configuration) in the inlet structure on the landside (LS). (Automatic Board Order (ABO) issued as Permit No. 9534, 1974 - Caleta). [Additional Reference(s): DWR Levee Log, 2002. USACE Sacramento O&M Manual 136, March 1960 (HLM 0.44)].

Waterside view: water flowing from CMP sewer pipe

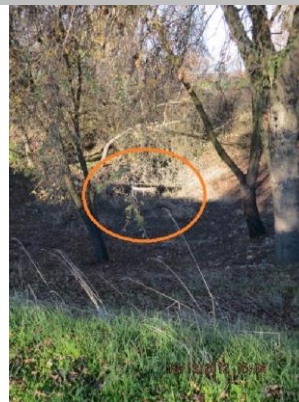
Photo 3 of 3 : UCIP_SP_2017_51650_46961.jpg

Landside view: overview

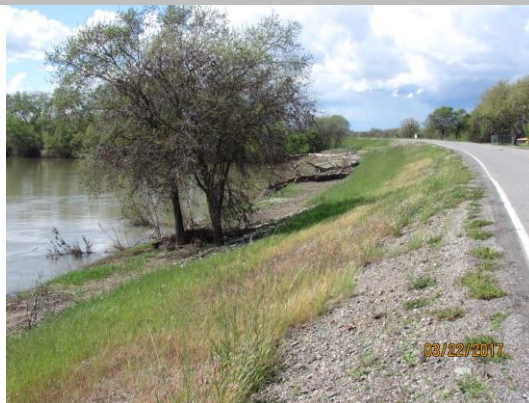
Photo 1 of 1 : SP_2017_ST0003_264_9_20170329_00181.jpg

LM Start	0.54	Rating **	M	Issue No.	9
LM End	0.68	Issue Type +	En	Location *	WS
Category	Earthen Levee			GPS Latitude/Longitude	
				Start	End
Item	Encroachments			39.197267 °	39.198178 °
				-121.944232 °	-121.946412 °
DWR ID	DWR_ST0003_01_s_2017_9				
Comment Code					
DE : Debris					
Inspector Comment					
Remove the debris from the waterside slope.

View of the debris along the waterside slope.

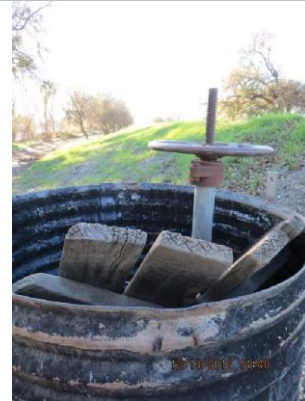
Photo 2 of 3 : UCIP_SP_2017_51653_46981.jpg

FS_ID:51653
DS_ID:17319
EP_NO: 9527
Repair Type: Urgent
Crossing Status: Found
UCIP Comments: 4/24/2017 LS slope dsamage is still present. No repairs have been made to this crossing yet. (DWR Sutter Yard- AFreitag)11/7/2016 No LS repairs have been made yet. (DWR Sutter Yard- AFreitag)6/6/2016 New flow meter installed on WS. Walkway to access the pump is overgrown with vegetation and not accessible. (DWR Sutter Yard - afreitag) 4/5/2016 Caved-in slope on landside (LS) not yet repaired. Leaky pipe marker gone. Per Bob Duffey (DWR FPIIB inspector), pipe will be replaced by owner next year. If not, will go to CVFPB enforcement. (DWR UCIP - kfazel)4/6/2015 Pipe leaks during times of High water. Slope damage still present. Needs a more detailed inspection to find the leak. (DWR Sutter Yard - afreitag)6/30/2014 Same as last inspection. (DWR Sutter Yard - afreitag)12/30/2013 Same as last inspection. (DWR Sutter Yard - afreitag)7/29/2013 Pipe does not appear to be abandoned. On the WS it appears that a smaller pipe was sleeved into the 18in. Pipe and then the difference capped and welded. Pump was not running at time of inspection but LS ditch near outlet was wet. LS slope damage and leaky pipe marker are still present. (DWR Sutter Yard - afreitag)12/13/2012 Abandoned and plugged/capped steel pipe on WS berm. DWR leaky pipe marker on LS (12-3). Slope failure on LS. Needs capping of LS steel pipe after detailed investigation. (DWR UCIP - pamatya)

FIELD_STRUCT_DESC: 18-inch steel irrigation pipe through the levee, 12.5 feet below the crown. Gate valve on the waterside (WS). Vertical pump on the WS bank. Flow meter on the WS. (Automatic Board Order (ABO) issued as Permit No. 9527, 1974 - Butte Creek Farms)
[Additional Reference(s): DWR Levee Log, 2002. USACE Sacramento O&M Manual 136, March 1960 (HLM 1.1)].
FS Date: 4/26/2017 9:49:08 AM

Waterside view: CMP riser with slide gate

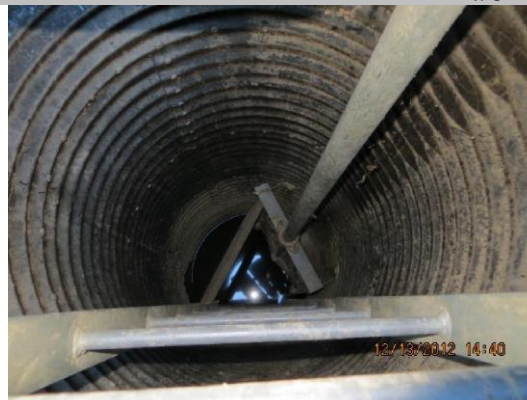
Photo 3 of 3 : UCIP_SP_2017_51653_46980.jpg

FS_ID:51653
DS_ID:17319
EP_NO: 9527
Repair Type: Urgent
Crossing Status: Found
UCIP Comments: 4/24/2017 LS slope dsamage is still present. No repairs have been made to this crossing yet. (DWR Sutter Yard- AFreitag)11/7/2016 No LS repairs have been made yet. (DWR Sutter Yard- AFreitag)6/6/2016 New flow meter installed on WS. Walkway to access the pump is overgrown with vegetation and not accessible. (DWR Sutter Yard - afreitag) 4/5/2016 Caved-in slope on landside (LS) not yet repaired. Leaky pipe marker gone. Per Bob Duffey (DWR FPIIB inspector), pipe will be replaced by owner next year. If not, will go to CVFPB enforcement. (DWR UCIP - kfazel)4/6/2015 Pipe leaks during times of High water. Slope damage still present. Needs a more detailed inspection to find the leak. (DWR Sutter Yard - afreitag)6/30/2014 Same as last inspection. (DWR Sutter Yard - afreitag)12/30/2013 Same as last inspection. (DWR Sutter Yard - afreitag)7/29/2013 Pipe does not appear to be abandoned. On the WS it appears that a smaller pipe was sleeved into the 18in. Pipe and then the difference capped and welded. Pump was not running at time of inspection but LS ditch near outlet was wet. LS slope damage and leaky pipe marker are still present. (DWR Sutter Yard - afreitag)12/13/2012 Abandoned and plugged/capped steel pipe on WS berm. DWR leaky pipe marker on LS (12-3). Slope failure on LS. Needs capping of LS steel pipe after detailed investigation. (DWR UCIP - pamatya)

Waterside view: inside CMP riser

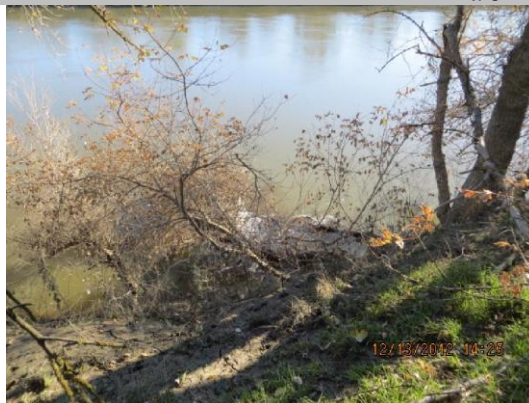
Photo 1 of 3 : UCIP_SP_2017_51655_46992.jpg

Comment Code					
Inspector Comment					
FS_ID:51655 DS_ID:17320 EP_NO: 9543 Repair Type: Urgent Crossing Status: Found UCIP Comments: 4/24/2017 WS was underwater during the site visit but I do not believe that any repairs have been made to this crossing yet. (DWR Sutter Yard- AFreitag)11/7/2016 No repairs have been made here yet. (DWR Sutter Yard- AFreitag)6/17/2016 River levels were down and the WS pipe end was exposed. WS end is completely rotten and damaged and flap gate has fallen off the end of the pipe (see pics). Pipe needs to be replaced or repaired. (DWR Sutter Yard - afreitag)4/5/2016 Erosion on WS slope still present. Pipe still fully submerged on WS and discharging into river during site visit. (DWR UCIP - kfazel)4/6/2015 Pipe leaks during high water. DWR employee said he suspects that the flap gate has rotted and fallen off WS end of pipe. Could not locate WS end of pipe to confirm. Water was flowing through this drain during field survey. (DWR Sutter Yard - afreitag)6/30/2014 Same as last inspection. (DWR Sutter Yard - afreitag)12/30/2013 Same as last inspection. (DWR Sutter Yard - afreitag)7/29/2013 Same as last inspection. (DWR Sutter Yard - afreitag) 12/13/2012 Water was flowing through this drain during field survey. (DWR UCIP - pamatya) FIELD_STRUCT_DESC: 30-inch corrugated metal drainage pipe (at 45 degrees) through the levee, 25.2 feet below the crown. Flap gate on the waterside (WS), not found in 2016. (Automatic Board Order (ABO) issued as Permit No. 9543, 1974 - Harada). [Additional Reference(s): DWR Levee Log, 2002. USACE Sacramento O&M Manual 136, revision March 1960 (HLM 1.38)] FS Date: 4/26/2017 9:57:29 AM

Waterside view: overview of river bank

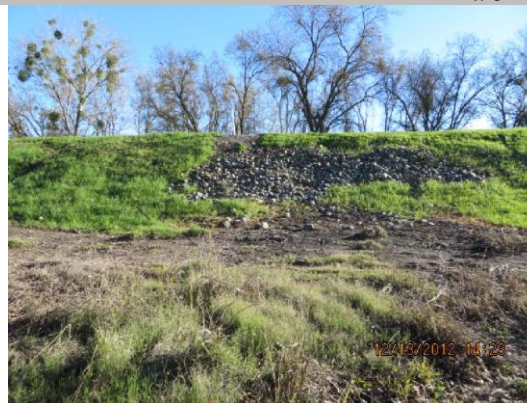
Photo 3 of 3 : UCIP_SP_2017_51655_46990.jpg

FS_ID:51655
DS_ID:17320
EP_NO: 9543
Repair Type: Urgent
Crossing Status: Found
UCIP Comments: 4/24/2017 WS was underwater during the site visit but I do not believe that any repairs have been made to this crossing yet. (DWR Sutter Yard- AFreitag)11/7/2016 No repairs have been made here yet. (DWR Sutter Yard- AFreitag)6/17/2016 River levels were down and the WS pipe end was exposed. WS end is completely rotten and damaged and flap gate has fallen off the end of the pipe (see pics). Pipe needs to be replaced or repaired. (DWR Sutter Yard - afreitag)4/5/2016 Erosion on WS slope still present. Pipe still fully submerged on WS and discharging into river during site visit. (DWR UCIP - kfazel)4/6/2015 Pipe leaks during high water. DWR employee said he suspects that the flap gate has rotted and fallen off WS end of pipe. Could not locate WS end of pipe to confirm. Water was flowing through this drain during field survey. (DWR Sutter Yard - afreitag)6/30/2014 Same as last inspection. (DWR Sutter Yard - afreitag)12/30/2013 Same as last inspection. (DWR Sutter Yard - afreitag)7/29/2013 Same as last inspection. (DWR Sutter Yard - afreitag) 12/13/2012 Water was flowing through this drain during field survey. (DWR UCIP - pamatya)

FIELD_STRUCT_DESC: 30-inch corrugated metal drainage pipe (at 45 degrees) through the levee, 25.2 feet below the crown. Flap gate on the waterside (WS), not found in 2016. (Automatic Board Order (ABO) issued as Permit No. 9543, 1974 - Harada). [Additional Reference(s): DWR Levee Log, 2002. USACE Sacramento O&M Manual 136, revision March 1960 (HLM 1.38)]
FS Date: 4/26/2017 9:57:29 AM

Landside view: overview of levee slope

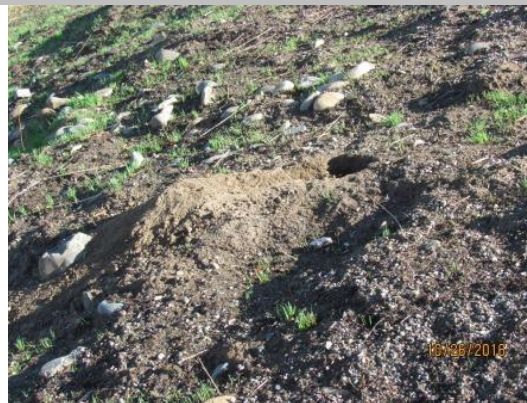
Photo 1 of 1 : SP_2017_ST0003_264_83_20170315_00026.jpg

LM Start	1.62	Rating **	M	Issue No.	83
LM End	1.62	Issue Type +	Ma	Location *	LS
Category	Earthen Levee			GPS Latitude/Longitude	
				Start	End
Item	Animal Control			39.190835 °	39.190835 °
				-121.960628 °	-121.960628 °
DWR ID	DWR_ST0003_01_f_2016_83				
Comment Code					
A1 : Exterminate rodents and backfill and compact or grout burrows.					
Inspector Comment

View of the rodent holes along the landside slope.

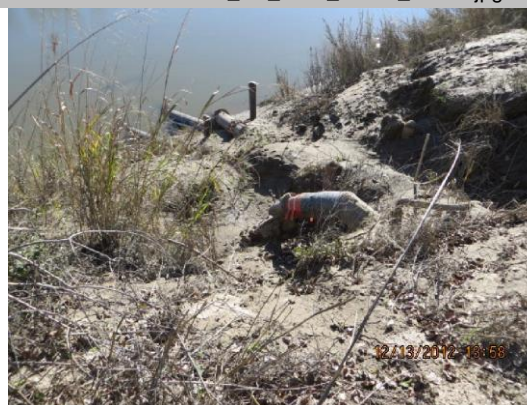
Photo 1 of 3 : UCIP_SP_2017_51656_46998.jpg

Comment Code					
Inspector Comment					
FS_ID:51656 DS_ID:17322 EP_NO: 9258 Repair Type: Non-Urgent Crossing Status: Found UCIP Comments: 4/24/2017 WS riser was still full of soil. Open 10" pipe on the WS bank was underwater during time of site visit. (DWR Sutter Yard- A Freitag)11/7/2016 WS riser still full of soil. No pump present and 10" pipe left opened on the WS. (DWR Sutter Yard- A Freitag)6/17/2016 Same as last inspection. 4/6/2015 CMP riser filled with silt/soil on WS. No other issues present.6/30/2014 Same as last inspection. 12/30/2013 Same as last inspection.7/29/2013 Same as last inspection. FIELD_STRUCT_DESC: 10-inch asphalt coated steel irrigation pipe through the levee, 3.7 feet below the crown. Pump installed on the waterside (WS). (Permit No. 9258, 1974 - Harada). [Additional Reference(s): DWR Levee Log, 2002]. FS Date: 4/26/2017 10:15:33 AM

Waterside view: overview

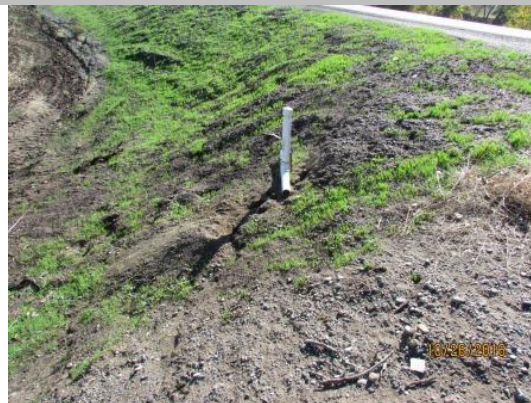
Photo 1 of 1 : SP_2017_ST0003_264_84_20170315_00027.jpg

LM Start	2.07	Rating **	M	Issue No.	84
LM End	2.07	Issue Type +	Ma	Location *	LS
Category	Earthen Levee			GPS Latitude/Longitude	
				Start	End
Item	Animal Control			39.187776 °	39.187776 °
				-121.967516 °	-121.967516 °
DWR ID	DWR_ST0003_01_f_2016_84				
Comment Code					
A1 : Exterminate rodents and backfill and compact or grout burrows.					
Inspector Comment

View of the rodent holes along the landside slope.

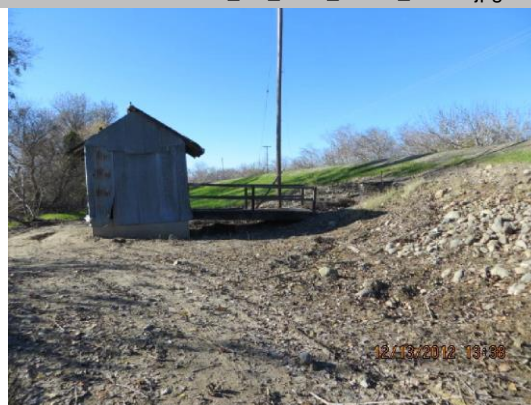
Photo 1 of 3 : UCIP_SP_2017_51658_47013.jpg

Comment Code					
Inspector Comment					
FS_ID:51658 DS_ID:17305 EP_NO: 9541 Repair Type: Non-Urgent Crossing Status: Found UCIP Comments: 4/24/2017 Abandoned and needs to be done so properly. (DWR Sutter Yard- A Freitag)11/7/2016 Abandoned. (DWR Sutter Yard- A Freitag)6/6/2016 Abandoned crossing. Should be properly abandoned.4/6/2015 Same as last inspection. CMP standpipe with gate valve. Abandoned pump house. Pipe discharges into open ditch at landward toe- not found.6/30/2014 Same as last inspection.12/30/2013 Same as last inspection.7/29/2013 Same as last inspection. FIELD_STRUCT_DESC: *ABANDONED* 24-inch irrigation pipe of an unknown material through the levee, 13.5 feet below the crown. Pump in a metal house on the WS (waterside) berm. Slide gate in a corrugated metal pipe riser on the WS slope. Service pole and guy wire anchor on the WS slope. (Automatic Board Order (ABO) issued as Permit No. 9541, 1974 - Wilbur, McGowan, Zinke). [Additional Reference(s): DWR Levee Logs, 2002. USACE Sacramento O&M Manual 136, March 1960 (HLM 2.01)]. FS Date: 4/26/2017 10:40:26 AM

Waterside view: overview

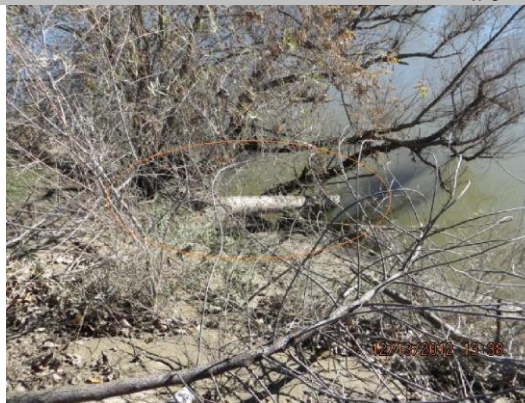
Photo 2 of 3 : UCIP_SP_2017_51658_47011.jpg

FS_ID:51658
DS_ID:17305
EP_NO: 9541
Repair Type: Non-Urgent
Crossing Status: Found
UCIP Comments: 4/24/2017 Abandoned and needs to be done so properly. (DWR Sutter Yard- AFreitag)11/7/2016 Abandoned. (DWR Sutter Yard- AFreitag)6/6/2016 Abandoned crossing. Should be properly abandoned.4/6/2015 Same as last inspection. CMP standpipe with gate valve. Abandoned pump house. Pipe discharges into open ditch at landward toe- not found.6/30/2014 Same as last inspection.12/30/2013 Same as last inspection.7/29/2013 Same as last inspection.
FIELD_STRUCT_DESC: *ABANDONED* 24-inch irrigation pipe of an unknown material through the levee, 13.5 feet below the crown. Pump in a metal house on the WS (waterside) berm. Slide gate in a corrugated metal pipe riser on the WS slope. Service pole and guy wire anchor on the WS slope. (Automatic Board Order (ABO) issued as Permit No. 9541, 1974 - Wilbur, McGowan, Zinke). [Additional Reference(s): DWR Levee Logs, 2002. USACE Sacramento O&M Manual 136, March 1960 (HLM 2.01)].

Waterside view: overview of pipe

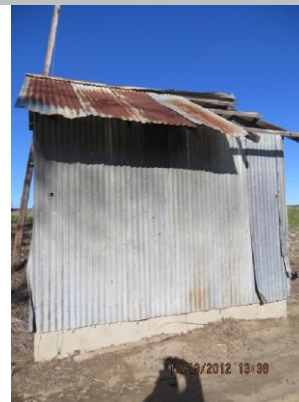
Photo 3 of 3 : UCIP_SP_2017_51658_47012.jpg

Waterside view: abandoned pump house

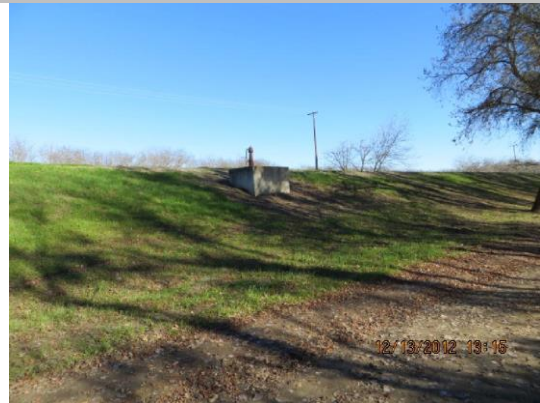
Photo 1 of 3 : UCIP_SP_2017_51660_47027.jpg

Comment Code					
Inspector Comment					
FS_ID:51660 DS_ID:17309 EP_NO: 9541 Repair Type: Non-Urgent Crossing Status: Found UCIP Comments: 4/24/2017 Still no sign of WS pipe end or flapgate. LS appears to be in good condition. (DWR Sutter Yard- AFreitag) 11/7/2016 LS culvert measured to be 30"wide X 30"tall. WS end is not visible so could not be measured. (DWR Sutter Yard- AFreitag)6/6/2016 Cannot locate the WS headwall/flapgate. Appears to have been silted over.4/6/2015 Same as last inspection. Concrete surg box on WS. Flap gate in concrete "U" headwall at the waterward end- not found.6/30/2014 Same as last inspection.12/30/2013 Same as last inspection.7/29/2013 Same as last inspection. FIELD_STRUCT_DESC: 30-inch reinforced concrete box drainage culvert through the levee, 14.3 feet below the crown. 30-inch corrugated metal pipe connects concrete culvert from slide gate out to flap gate on the waterside (WS) end. Slide gate in a concrete riser on the waterside (WS) slope. (Automatic Board Order (ABO) issued as Permit No. 9541, 1974 - Wilbur, McGowan, Zinke). [Additional Reference(s): DWR Levee Logs, 2002. USACE Sacramento O&M Manual 136, March 1960 (HLM 2.49)]. FS Date: 4/26/2017 10:46:22 AM

Waterside view: overview- concrete surg tank

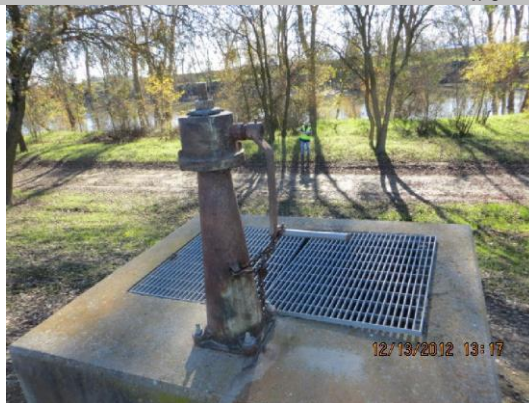
Photo 2 of 3 : UCIP_SP_2017_51660_47026.jpg

FS_ID:51660
DS_ID:17309
EP_NO: 9541
Repair Type: Non-Urgent
Crossing Status: Found
UCIP Comments: 4/24/2017 Still no sign of WS pipe end or flapgate. LS appears to be in good condition. (DWR Sutter Yard- AFreitag)

11/7/2016 LS culvert measured to be 30"wide X 30"tall. WS end is not visible so could not be measured. (DWR Sutter Yard- AFreitag)6/6/2016 Cannot locate the WS headwall/flapgate. Appears to have been silted over.4/6/2015 Same as last inspection. Concrete surg box on WS. Flap gate in concrete "U" headwall at the waterward end- not found.6/30/2014 Same as last inspection.12/30/2013 Same as last inspection.7/29/2013 Same as last inspection.
FIELD_STRUCT_DESC: 30-inch reinforced concrete box drainage culvert through the levee, 14.3 feet below the crown. 30-inch corrugated metal pipe connects concrete culvert from slide gate out to flap gate on the waterside (WS) end. Slide gate in a concrete riser on the waterside (WS) slope. (Automatic Board Order (ABO) issued as Permit No. 9541, 1974 - Wilbur, McGowan, Zinke). [Additional Reference(s): DWR Levee Logs, 2002. USACE Sacramento O&M Manual 136, March 1960 (HLM 2.49)].

Waterside view: overview- concrete surg tank

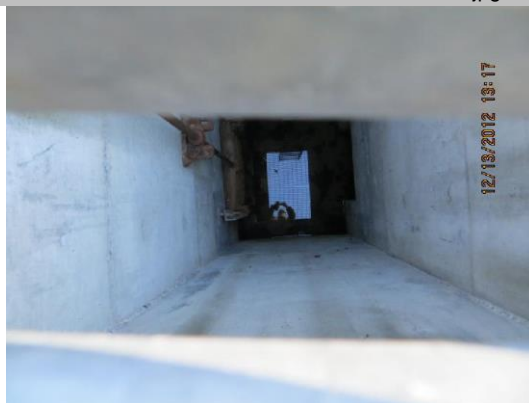
Photo 3 of 3 : UCIP_SP_2017_51660_47025.jpg

Waterside view: slide gate inside concrete surg tank

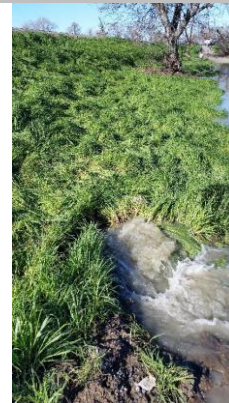
Photo 1 of 3 : UCIP_SP_2017_51665_76919.jpg

Comment Code					
Inspector Comment					
FS_ID:51665 DS_ID:17311 EP_NO: N/A Repair Type: Urgent Crossing Status: Found UCIP Comments: 4/6/2017 Pipe was found in January 2017 during a high water event when water uncovered the buried WS end which led to uncontrolled water flow through during the high water event. The WS pipe opening was temporarily blocked off by plywood and sandbags until the pipe can be properly plugged or abandoned. Pics updated. (DWR Sutter Yard- Afreitag)11/7/2016 Unable to locate. (DWR Sutter Yard- Afreitag)6/6/2016 Unable to locate.4/6/2015 Unable to locate.6/30/2014 Unable to locate.12/30/2013 Unable to locate.7/29/2013 Same as last inspection. Unable to locate. FIELD_STRUCT_DESC: *ABANDONED* 24-inch corrugated metal drainage pipe through the levee, 12.4 feet below the crown. Slide gate on the waterside (WS) end. Pipe silted over on both ends. (Automatic Board Order (ABO) issued as Permit No. 9539, 1974 - Locvich). [Additional Reference(s): DWR Levee Log, 2002. USACE Sacramento O&M Manual 136, March 1960 (HLM 3.25)]. FS Date: 4/26/2017 12:09:42 PM

LS view of water exiting the pipe.

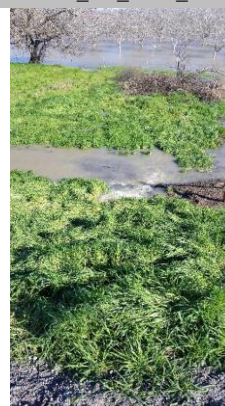
Photo 2 of 3 : UCIP_SP_2017_51665_76920.jpg

Comment Code					
Inspector Comment					
FS_ID:51665 DS_ID:17311 EP_NO: N/A Repair Type: Urgent Crossing Status: Found UCIP Comments: 4/6/2017 Pipe was found in January 2017 during a high water event when water uncovered the buried WS end which led to uncontrolled water flow through during the high water event. The WS pipe opening was temporarily blocked off by plywood and sandbags until the pipe can be properly plugged or abandoned. Pics updated. (DWR Sutter Yard- Afreitag)11/7/2016 Unable to locate. (DWR Sutter Yard- AFreitag)6/6/2016 Unable to locate.4/6/2015 Unable to locate.6/30/2014 Unable to locate.12/30/2013 Unable to locate.7/29/2013 Same as last inspection. Unable to locate. FIELD_STRUCT_DESC: *ABANDONED* 24-inch corrugated metal drainage pipe through the levee, 12.4 feet below the crown. Slide gate on the waterside (WS) end. Pipe silted over on both ends. (Automatic Board Order (ABO) issued as Permit No. 9539, 1974 - Locvich). [Additional Reference(s): DWR Levee Log, 2002. USACE Sacramento O&M Manual 136, March 1960 (HLM 3.25)]. FS Date: 4/26/2017 12:09:42 PM

LS view from levee shoulder

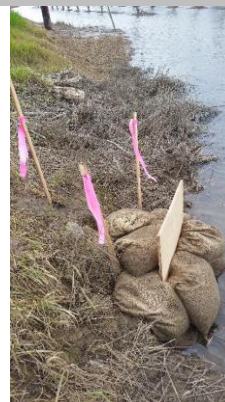
Photo 3 of 3 : UCIP_SP_2017_51665_76921.jpg

WS view of the temporary plug on WS end.

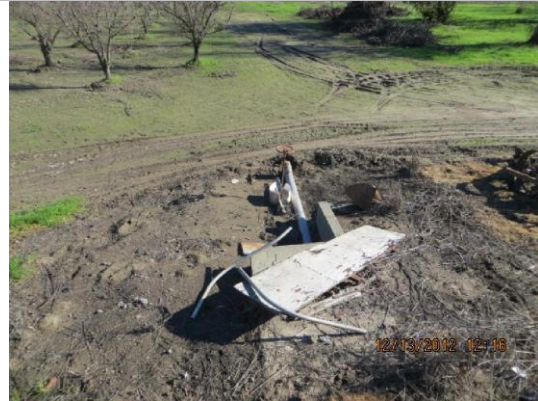
Photo 2 of 3 : UCIP_SP_2017_51664_47046.jpg

FS_ID:51664
DS_ID:17312
EP_NO: 9539
Repair Type: Urgent
Crossing Status: Found
UCIP Comments: 4/24/2017 Pipe leaked during the Jan/Feb 2017 high water event. Gap between the top of the WS headwall and concrete plug plus the WS airvents going underwater are the cause of the uncontrolled water flows. (DWR Sutter Yard- AFreitag)11/7/2016 Nothing has changed with this crossing since the last inspection. The gap between the top of the WS headwall and concrete plug could be a problem with water flow during high water times. (DWR Sutter Yard- AFreitag)6/6/2016 One of the pipes appear to be leaking inside of the concrete culvert. From the WS headwall water can be heard flowing inside of the levee behind the concrete plug. The concrete plug also appears to leak as water current can be seen flowing around it. There is also a 1" gap at the top of the plug and the old WS headwall that will allow high water to flow through uncontrolled. (DWR Sutter Yard - afreitag)4/6/2015 6-inch and 18-inch pipes still present in crossing and WS end still plugged with concrete. It seems that the system was originally designed for drainage but later converted into an irrigation system. 6-inch GI pipe and 18-inch PVC pipes inserted into culvert from LS (not plugged). WS opening is plugged with concrete. Probably pump is located 350 ft from levee as seen from Google Earth Map. (DWR Sutter Yard - afreitag)6/30/2014 Same as last inspection. (DWR Sutter Yard - afreitag)12/30/2013 Same as last inspection. (DWR Sutter Yard - afreitag)7/29/2013 Same as last inspection. (DWR Sutter Yard - afreitag)

FIELD_STRUCT_DESC: 30-inch by 36-inch reinforced concrete box drainage and irrigation culvert through the levee, invert 13.6 feet below the crown. Gates with 2-inch flashboards on the waterside (WS) end. 6-inch and 18-inch polyvinyl chloride (PVC) pipes through the culvert on the landside (LS). Culvert designed for drainage but now used for irrigation. (Automatic Board Order (ABO) issued as Permit No. 9539, 1974 - Locvich). [Additional Reference(s): DWR Levee Log, 2002. USACE Sacramento O&M Manual 136, March 1960 (HLM 3.33)].
FS Date: 4/26/2017 11:04:03 AM

Landside view: overview- concrete culvert and pipes

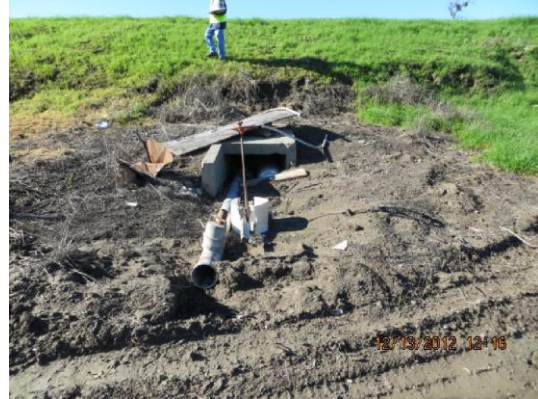
Photo 3 of 3 : UCIP_SP_2017_51664_47047.jpg

FIELD_STRUCT_DESC: 30-inch by 36-inch reinforced concrete box drainage and irrigation culvert through the levee, invert 13.6 feet below the crown. Gates with 2-inch flashboards on the waterside (WS) end. 6-inch and 18-inch polyvinyl chloride (PVC) pipes through the culvert on the landside (LS). Culvert designed for drainage but now used for irrigation. (Automatic Board Order (ABO) issued as Permit No. 9539, 1974 - Locvich). [Additional Reference(s): DWR Levee Log, 2002. USACE Sacramento O&M Manual 136, March 1960 (HLM 3.33)].
FS Date: 4/26/2017 11:04:03 AM

Landside view: overview of concrete culvert and pipes

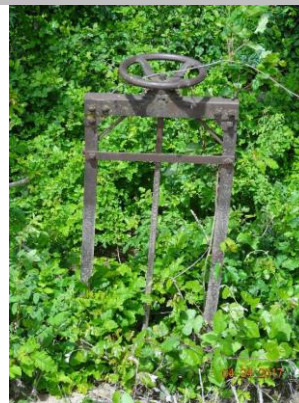
Photo 1 of 2 : UCIP_SP_2017_51666_77004.jpg

FS_ID:51666
DS_ID:17313
EP_NO: N/A
Repair Type: Non-Urgent
Crossing Status: Found
UCIP Comments: 4/24/2017 Slide gate structure found on WS about 10ft from levee toe. Vegetation was too thick to see if there were any more appurtances associated with this crossing visible on the WS. Nothing was visible on the LS. House located above pipe alignment at LS levee toe. Crossing appears abandoned and should be done so properly. (DWR Sutter Yard- AFreitag)11/7/2016 Unable to locate. (DWR Sutter Yard- AFreitag)6/6/2016 Unable to locate.4/6/2015 Unable to locate.6/30/2014 Unable to locate.12/30/2013 Unable to locate7/29/2013 Same as last inspection. Unable to locate.
FIELD_STRUCT_DESC: *ABANDONED* 18-inch corrugated metal drainage pipe through the levee, 15 feet below the crown. Slide gate on the waterside (WS) end. [Additional Reference(s): DWR Levee Log, 2002. USACE Sacramento O&M Manual 136, March 1960 (HLM 3.6)].

Slide gate structure found on WS

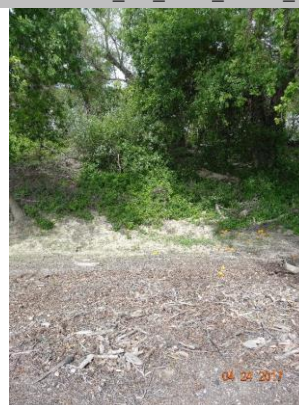
Photo 2 of 2 : UCIP_SP_2017_51666_77005.jpg

View of WS from levee shoulder

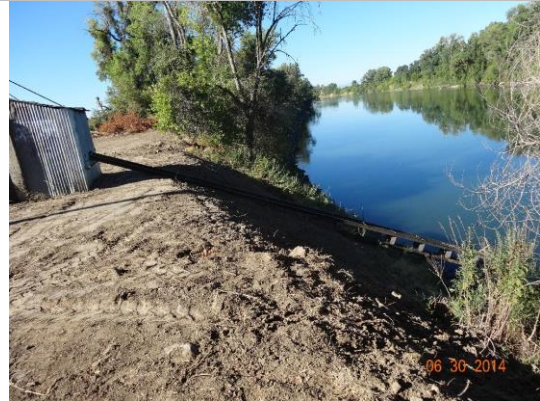
Photo 1 of 3 : UCIP_SP_2017_51671_71480.jpg

FS_ID:51671
DS_ID:17314
EP_NO: 9501-1
Repair Type: Non-Urgent
Crossing Status: Found
UCIP Comments: 4/24/2017 Crossing appears to be in good condition. (DWR Sutter Yard- AFreitag)11/7/2016 Crossing appears to be in good condition. (DWR Sutter Yard- AFreitag)6/17/2016 DO NOT BELIEVE THIS IS AN ABANDONED CROSSING- there is a newer looking pump present inside the WS pump house with an active PG&E power meter. Also the dirt below the siphon breaker inside of the riser on the LS shoulder was wet indicating that the breaker has had running water through it recently. Also the ground under the LS toe airvent was wet indicating that it too has recently had water flowing through it.

4/4/2016 Concrete box on LS still silted in. Cracking and slope failure previously cited appears to have been repaired as we could not locate. Shutoff valves appear in good condition. If crossing is abandoned, should be done so properly.4/6/2015 Same as last inspection. Concrete pit on WS berm. Concrete distribution box on LS silted and erosion around the box. Slope failure/ transverse cracks on LS levee slope. Two depressions on WS berm.6/30/2014 Crossing appears to be being made active again. WS bank has been cleared of all vegetation and debris to allow pump to slide down to water level. New shutoff valve installed on WS shoulder inside of cmp stand pipe. New air-vac installed inside cmp standpipe on LS shoulder and air vent installed on LS toe. Could not Locate pipe end on LS. Need to check for permit number for work done.12/30/2013 Repairs to LS and WS slopes have been completed. Not sure if this is an active or abandoned crossing. LS distribution box is still silted in.7/29/2013 Repairs to LS slope and pipe are in progress. Nothing has been done yet to the WS depressions.

WS river bank

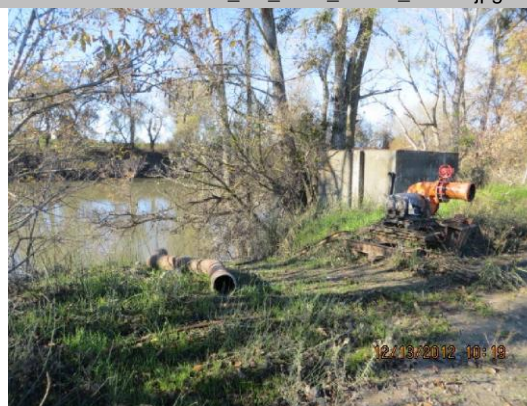
Photo 2 of 3 : UCIP_SP_2017_51674_47067.jpg

FS_ID:51674
DS_ID:17297
EP_NO: 9501-A
Repair Type: Urgent
Crossing Status: Found
UCIP Comments: 4/24/2017 WS was mostly underwater during site visit. Not sure if the 10" pipe was still opened or capped on the WS end but no water appeared to be free flowing through the levee. No sign of orange pump. (DWR Sutter Yard- AFreitag)11/7/2016 Orange pump was not present at this inspection. 10" pipe penetration left opened on WS end. (DWR Sutter Yard- AFreitag)6/17/2016 Orange pump motor was lowered down the WS berm to water level and was pumping water through the pipe to the LS outlet. What is pictured in (photo#17 UCIP_Photos_No.75150) as "pipe debris" is the pipe section that is used to connect the orange pump to the open 10" pipe that penetrates the levee. In the same photo the "possible penetration" is the flexible suction line for the pump. (DWR Sutter Yard - afreitag)4/4/2016 Flow meter installed on LS indicates this pipe is used seasonally and not abandoned. Pipe open on WS (see photo). No cover on old siphon breaker. Slight sloughing of LS slope. (DWR UCIP - kfazel)4/6/2015 Pump disconnected and pulled up to WS toe. Not Sure if leaky valve has ever been fixed. (DWR Sutter Yard - afreitag)6/30/2014 Same as last inspection. (DWR Sutter Yard - afreitag)12/30/2013 Same as last inspection. (DWR Sutter Yard - afreitag)7/29/2013 Not an abandoned crossing. Pump is connected to WS pipe end at water level and is pumping water to LS and then goes underground to an irrigation ditch about 100yds. upstream. Pump and pipes are disconnected and pulled up to WS toe for high water season. Leaky valve on LS shoulder does not appear to have been fixed. (DWR Sutter Yard - afreitag)12/12/2012 Motor and pump on berm. Appears an abandoned crossing. Leaky valve on LS slope. Pipe removed and laying on berm. No electric connection to the pump. (DWR UCIP - pamatya)

Waterside view: overview of pump and abandoned pipe

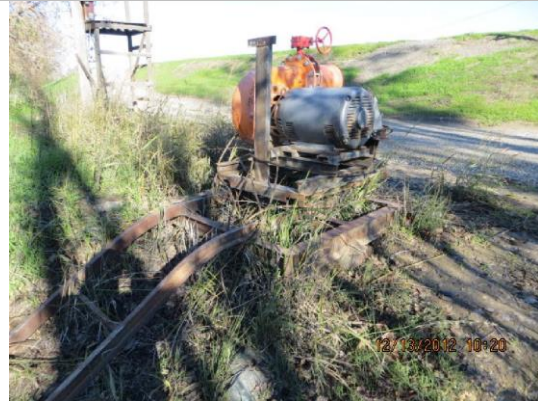
Photo 3 of 3 : UCIP_SP_2017_51674_47066.jpg

WS view: pump motor on the berm (found at water level in 2016)

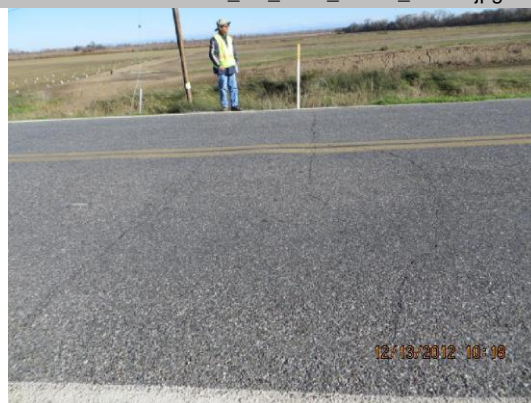
Photo 1 of 3 : UCIP_SP_2017_51675_47080.jpg

FS_ID:51675
 DS_ID:17326
 EP_NO: 9501
 Repair Type: Urgent
 Crossing Status: Found
 UCIP Comments: 4/24/2017 Abandoned and needs to be done properly. (DWR Sutter Yard- AFreitag)11/7/2016 Abandoned and should be done so properly. (DWR Sutter Yard- AFreitag)6/17/2016 Abandoned pipe. photo comments updated. (DWR Sutter Yard - afreitag)4/4/2016 Open on WS. Needs proper abandonment. Contact owner to determine status of crossing. (DWR UCIP - kfazel)4/6/2015 Same as last inspection. (DWR Sutter Yard - afreitag)6/30/2014 Same as last inspection. (DWR Sutter Yard - afreitag)12/30/2013 Same as last inspection. (DWR Sutter Yard - afreitag)7/29/2013 Same as last inspection. (DWR Sutter Yard - afreitag)12/12/2012 Need to be properly abandoned. Transverse cracks on levee road. Also found a concrete outlet on LS. It is not clear whether this passes through the levee. (DWR UCIP - pamatya)
 FIELD_STRUCT_DESC: *ABANDONED* 16-inch steel irrigation pipe, 13.9 feet below the crown. Gate valve and pump in pump house on the waterside (WS) berm. 2-3 inch electrical conduit penetrates levee alongside pipe. Flap gate and concrete distribution box on the landside (LS). (Automatic Board Order (ABO) issued as Permit No. 9501, 1974 - Mayfair Farms, abandoned under Permit No. 9501-A, 1978 - Mayfair Packing, Inc.). [Additional Reference(s): DWR Levee Log, 2002. USACE Sacramento O&M Manual 136, March 1960 (HLM 4.37)]

LM Start	4.44	Rating **	U	Issue No.	145 (cont)
LM End	4.44	Issue Type +	En	Location *	WS

Crown view: cracks along pipe alignment (transverse crack)

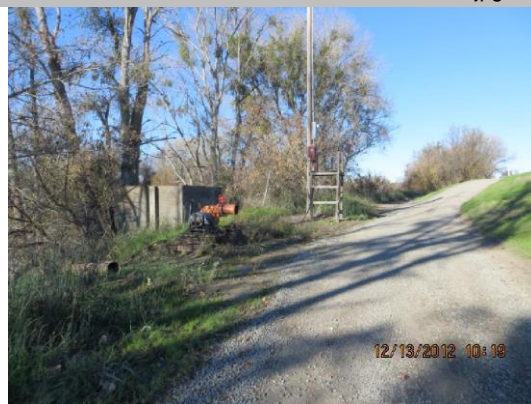
Photo 2 of 3 : UCIP_SP_2017_51675_47079.jpg

Waterside view: overview

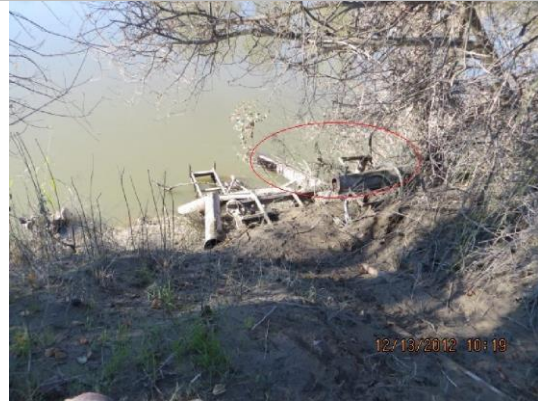
Photo 3 of 3 : UCIP_SP_2017_51675_47078.jpg

FS_ID:51675
DS_ID:17326
EP_NO: 9501
Repair Type: Urgent
Crossing Status: Found
UCIP Comments: 4/24/2017 Abandoned and needs to be done properly. (DWR Sutter Yard- AFreitag)11/7/2016 Abandoned and should be done so properly. (DWR Sutter Yard- AFreitag)6/17/2016 Abandoned pipe. photo comments updated. (DWR Sutter Yard - afreitag)4/4/2016 Open on WS. Needs proper abandonment. Contact owner to determine status of crossing. (DWR UCIP - kfazel)4/6/2015 Same as last inspection. (DWR Sutter Yard - afreitag)6/30/2014 Same as last inspection. (DWR Sutter Yard - afreitag)12/30/2013 Same as last inspection. (DWR Sutter Yard - afreitag)7/29/2013 Same as last inspection. (DWR Sutter Yard - afreitag)12/12/2012 Need to be properly abandoned. Transverse cracks on levee road. Also found a concrete outlet on LS. It is not clear whether this passes through the levee. (DWR UCIP - pamatya)
FIELD_STRUCT_DESC: *ABANDONED* 16-inch steel irrigation pipe, 13.9 feet below the crown. Gate valve and pump in pump house on the waterside (WS) berm. 2-3 inch electrical conduit penetrates levee alongside pipe. Flap gate and concrete distribution box on the landside (LS). (Automatic Board Order (ABO) issued as Permit No. 9501, 1974 - Mayfair Farms, abandoned under Permit No. 9501-A, 1978 - Mayfair Packing, Inc.). [Additional Reference(s): DWR Levee Log, 2002. USACE Sacramento O&M Manual 136, March 1960 (HLM 4.37)]

Waterside view: overview of pipe

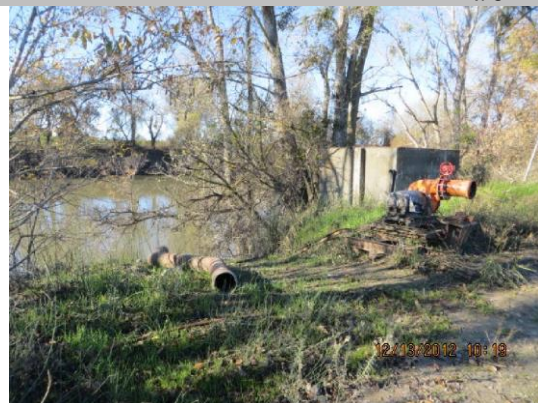
Photo 2 of 3 : UCIP_SP_2017_51676_47086.jpg

FS_ID:51676
DS_ID:17484
EP_NO: N/A
Repair Type: Non-Urgent
Crossing Status: Found
UCIP Comments: 4/24/2017 Abandoned- needs to be done so properly. WS underwater during site visit. (DWR Sutter Yard- AFreitag)11/7/2016 Abandoned but needs to be done so properly. (DWR Sutter Yard- AFreitag)9/29/2016 Crossing has been downgraded from Urgent to Non-Urgent crossing is abandoned and WS surge box is full of debris. Need to contact owner and have owner coordinate with CVFPB to comply with Title 23. (DWR UCIP - omagana)6/17/2016 Abandoned crossing. Photo comments updated. (DWR Sutter Yard - afreitag)4/4/2016 Same as last inspection. (DWR UCIP - kfazel)4/6/2015 Crossing appears to be an old irrigation structure and not a drain pipe. It appears abandoned as WS surge box is full of debris. (DWR Sutter Yard - afreitag)6/30/2014 Same as last inspection. (DWR Sutter Yard - afreitag)12/30/2013 Same as last inspection. (DWR Sutter Yard - afreitag)7/29/2013 Same as last inspection. (DWR Sutter Yard - afreitag)12/12/2012 Debris and deteriorated concrete. Gate valve in surge tank. (DWR UCIP - pamatya) FIELD_STRUCT_DESC: *ABANDONED* 24-inch steel irrigation pipe through the levee, invert 26 feet below the crown. Slide gate on the waterside (WS). [Additional Reference(s): USACE Sacramento O&M Manual 136, March 1960 (HLM 4.37)].

Waterside view: overview of concrete surge box

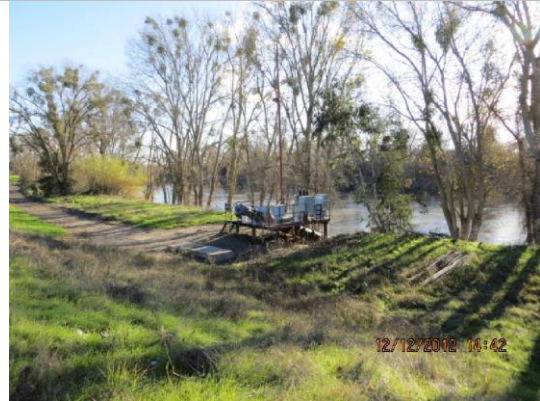
Photo 1 of 3 : UCIP_SP_2017_51677_47092.jpg

FS_ID:51677
DS_ID:17318
EP_NO: 9501
Repair Type: Non-Urgent
Crossing Status: Found
UCIP Comments: 4/24/2017 LS shoulder erosion repaired. Not sure if any changes or repairs were done to the pipe itself. (DWR Sutter Yard- AFreitag)11/7/2016 LS erosion still a problem at the LS shoulder. (DWR Sutter Yard- AFreitag)6/6/2016 LS erosion still present and appears to be getting worse. It is only a few inches away from affecting the paved road way. (DWR Sutter Yard - afreitag)4/4/2016 Same as last inspection. Erosion problem is urgently in need of repair. (DWR UCIP - kfazel)4/6/2015 Erosion problem still present near the LS shoulder. If it gets any worse then it may start to affect the road way. Found a siphon breaker on LS. Antenna and pump station on WS. Huge erosion on LS slope. (DWR Sutter Yard - afreitag)6/30/2014 Same as last inspection. (DWR Sutter Yard - afreitag)12/30/2013 Same as last inspection. (DWR Sutter Yard - afreitag)7/29/2013 Erosion near LS shoulder may start affecting the roadway if it gets any worse.12/12/2012 Found a siphon breaker on LS. Antenna and pump station on WS. Huge erosion on LS slope. (DWR UCIP - pamatya) FIELD_STRUCT_DESC: 24-inch asphalt coated steel irrigation pipe, 4 feet below the crown. Slant pump on a steel platform on the waterside (WS) berm. Siphon breaker on the apex of the pipe and off the levee crown on the landside (LS). 2 shut-off (butterfly) valves off the LS toe. Power pole with electrical conduit and panel on the LS toe. Pipe appears to run diagonally through the levee and discharges into a ditch off the LS toe. Gate structure on the outlet at the ditch. (Automatic Board Order (ABO) issued as Permit No. 9501, 1974 - Mayfair Farms, Inc.). Slant pump installed under Permit No. 10935, 1975 - Pires. [Additional Reference(s): DWR Levee Log, 2002].

Waterside view: overview

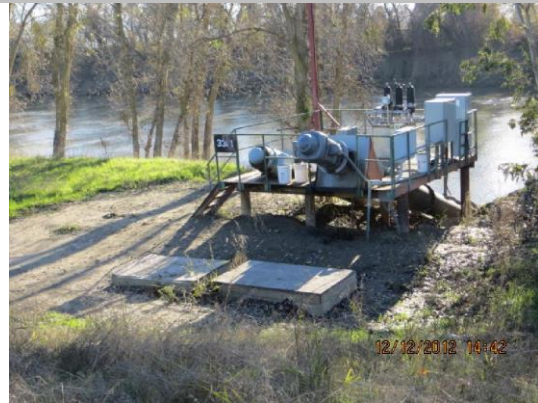
Photo 2 of 3 : UCIP_SP_2017_51677_47091.jpg

Waterside view: overview of pump station

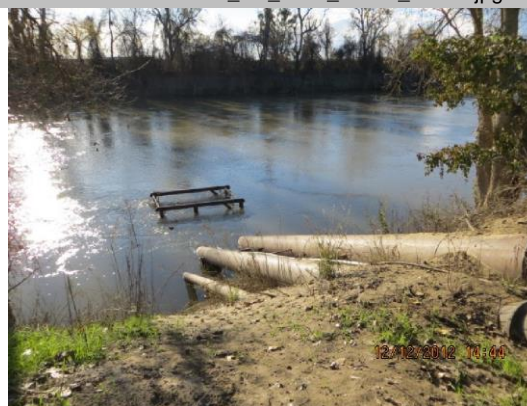
Photo 3 of 3 : UCIP_SP_2017_51677_47096.jpg

Waterside view: inclined pipes

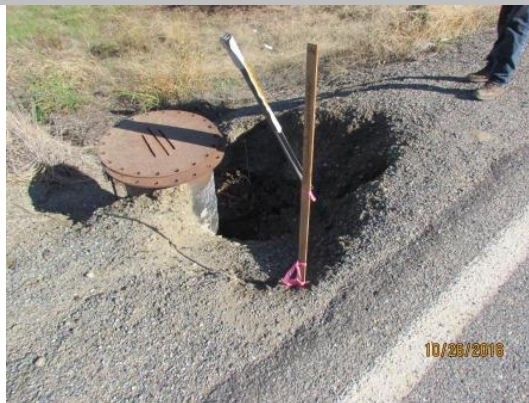
Photo 1 of 1 : SP_2017_ST0003_264_106_20170315_00033.jpg

LM Start	4.64	Rating **	M	Issue No.	106
LM End	4.64	Issue Type +	Ma	Location *	LS
Category	Earthen Levee			GPS Latitude/Longitude	
				Start	End
Item	Erosion / Bank Caving			39.212632 °	39.212632 °
				-121.990409 °	-121.990409 °
DWR ID	DWR_ST0003_01_f_2016_106				
Comment Code					
E2 : Schedule repair of erosion site prior to the next inspection.					
Inspector Comment

View of the erosion next to a pipe along the landside slope.

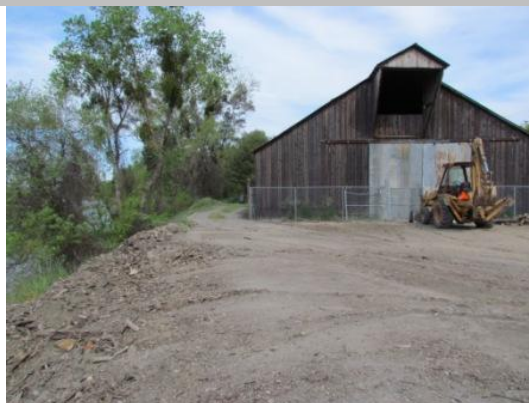
Photo 1 of 1 : SP_2017_ST0003_264_12_20170315_00009.jpg

LM Start	4.72	Rating **	M	Issue No.	12
LM End	4.72	Issue Type +	En	Location *	CR
Category	Earthen Levee			GPS Latitude/Longitude	
				Start	End
Item	Encroachments			39.213265 °	39.213265 °
				-121.991672 °	-121.991672 °
DWR ID	DWR_ST0003_01_s_2012_12				
Comment Code					
BU : Building					
Inspector Comment

View of the barn on the large crown of the levee.

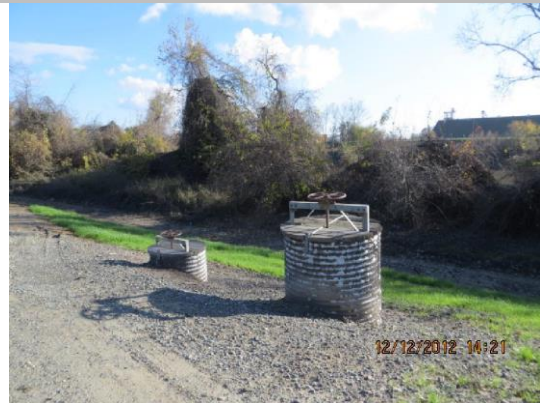
Photo 1 of 3 : UCIP_SP_2017_51679_47107.jpg

Comment Code					
Inspector Comment					
FS_ID:51679 DS_ID:17287 EP_NO: 9520 Repair Type: Non-Urgent Crossing Status: Indicator Found UCIP Comments: 4/24/2017 Abandoned- needs to be done properly. (DWR Sutter Yard- AFreitag)11/7/2016 appears abandoned and should be done so properly. (DWR Sutter Yard- AFreitag)6/6/2016 Appears to be an abandoned crossing.4/6/2015 Same as last inspection. Still appears abandoned. A concrete standpipe and a CMP riser on WS. It seems abandoned and if so should be done so properly.6/30/2014 Same as last inspection.12/30/2013 Same as last inspection.7/29/2013 Same as last inspection. FIELD_STRUCT_DESC: *ABANDONED* 24-inch corrugated metal drainage pipe through the levee, 17 feet below the crown, not found in 2015. Slide gate in a corrugated metal pipe (CMP) riser on the waterside (WS) slope, found in 2015. Pump on the WS bank and concrete standpipe on the WS berm, found in 2015. 18-inch concrete pipe from standpipe at WS toe. Pipe discharges into a field on the landside (LS), not found in 2015. (Automatic Board Order (ABO) issued as Permit No. 9520, 1974 - Arnold). [Additional Reference(s): DWR Levee Log, 2002. USACE Sacramento O&M Manual 136, March 1960 (HLM 4.99)]. FS Date: 4/26/2017 1:07:37 PM

Waterside view: overview

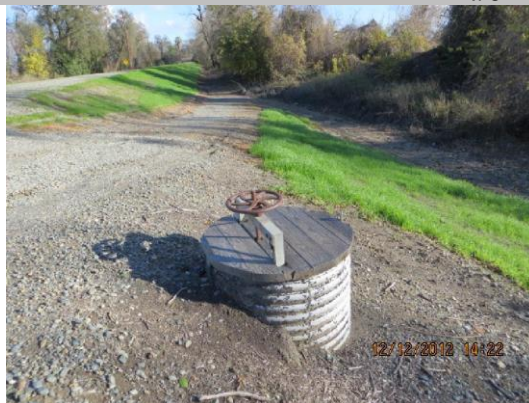
Photo 2 of 3 : UCIP_SP_2017_51679_47106.jpg

Waterside view: CMP riser with slide gate

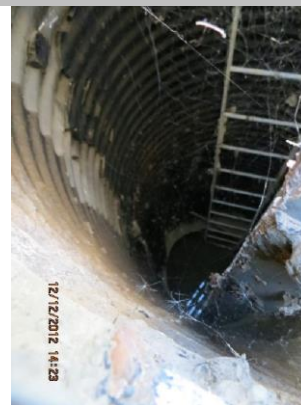
Photo 3 of 3 : UCIP_SP_2017_51679_47105.jpg

Waterside view: inside CMP riser

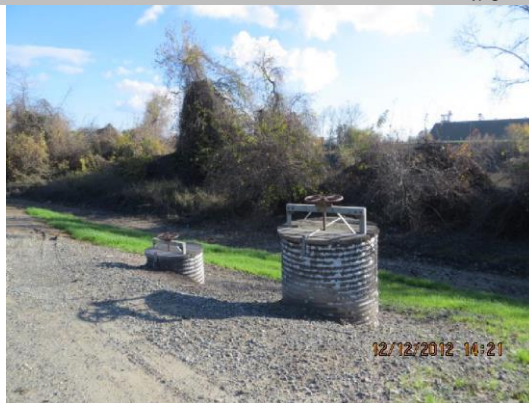
Photo 1 of 3 : UCIP_SP_2017_51680_47112.jpg

Waterside view: CMP riser with slide gate (right)

Comment Code					
Inspector Comment					
FS_ID:51680 DS_ID:17288 EP_NO: N/A Repair Type: Non-Urgent Crossing Status: Indicator Found UCIP Comments: 4/24/2017 Abandoned- needs to be done so properly. (DWR Sutter Yard- AFreitag)11/7/2016 Appears abandoned, Should be done so properly. (DWR Sutter Yard- AFreitag)6/6/2016 Appears to be an abandoned crossing.4/4/2016 If abandoned, should be done so properly.4/6/2015 Same as last inspection. Only WS riser amd slide gate found.Only a CMP riser with slide gate found on WS.6/30/2014 Same as last inspection.12/30/2013 Same as last inspection.7/29/2013 Same as last inspection. FIELD_STRUCT_DESC: *ABANDONED* 36-inch corrugated metal drainage pipe through the levee, 13.8 feet below the crown, not found in 2015. Slide gate in a CMP riser on the waterside (WS) slope, found in 2015. Flap gate removed at the landside (LS) end. (Automatic Board Order (ABO) issued as Permit No. 9520, 1974 - Arnold). [Additional Reference(s): DWR Levee Log, 2002. USACE Sacramento O&M Manual 136, March 1960 (HLM 4.99)]. FS Date: 4/26/2017 1:19:25 PM

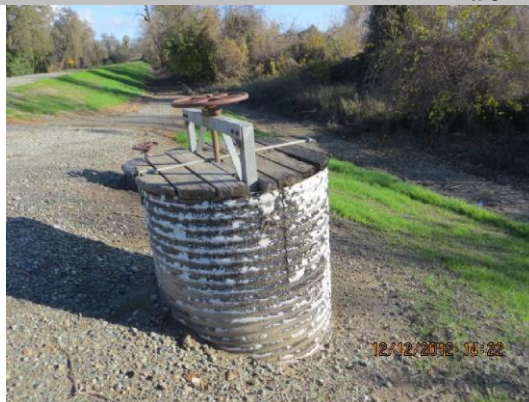
Photo 2 of 3 : UCIP_SP_2017_51680_47111.jpg

Waterside view: CMP riser with slide gate

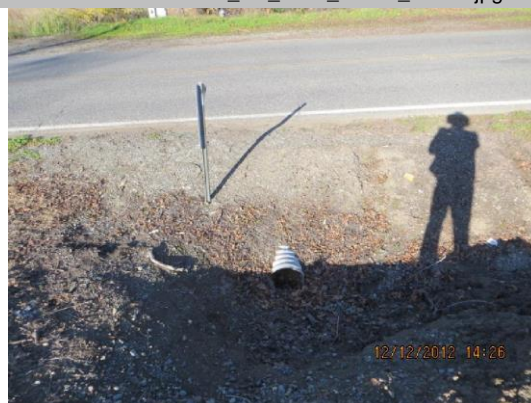
Photo 3 of 3 : UCIP_SP_2017_51680_47110.jpg

Landside view: overview- county road and road drainpipe

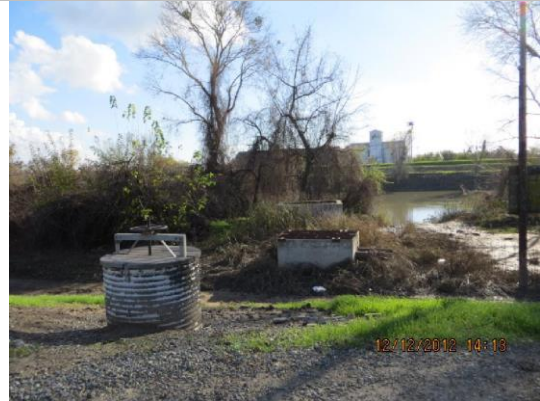
Photo 2 of 3 : UCIP_SP_2017_51681_47113.jpg

Waterside view: CMP riser and surge box

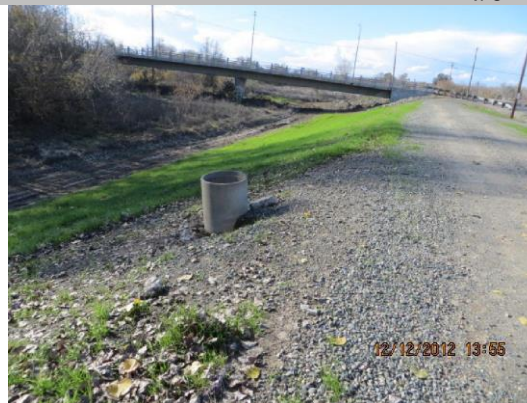
Photo 1 of 3 : UCIP_SP_2017_51683_47127.jpg

LM Start	5.15	Rating **	M	Issue No.	151 (cont)
LM End	5.15	Issue Type +	En	Location *	CR

Waterside view: concrete pipe riser with gate valve

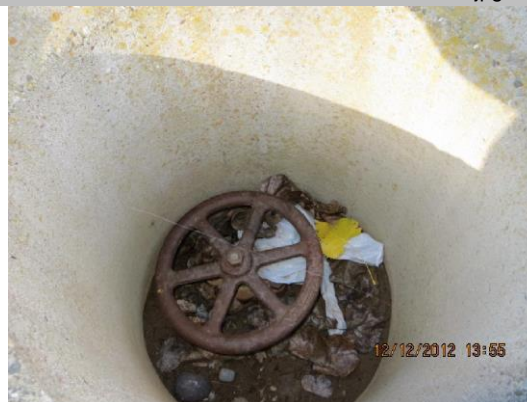
Photo 2 of 3 : UCIP_SP_2017_51683_47126.jpg

Waterside view: buried gate valve in concrete pipe riser

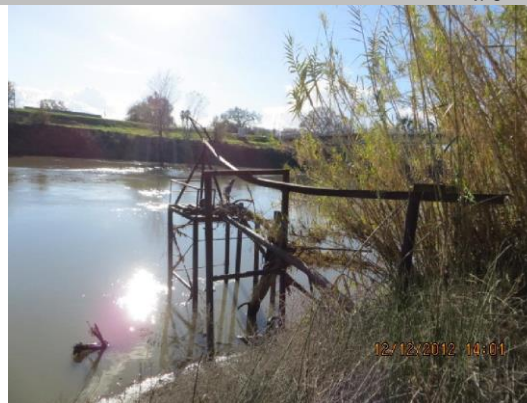
Photo 3 of 3 : UCIP_SP_2017_51683_47129.jpg

Comment Code					
Inspector Comment					
FS_ID:51683 DS_ID:17291 EP_NO: 4091 Repair Type: Non-Urgent Crossing Status: Found UCIP Comments: 4/24/2017 Abandoned- needs to be done properly. (DWR Sutter Yard- AFreitag) 11/7/2016 Abandoned and should be done so properly. (DWR Sutter Yard- AFreitag)6/6/2016 Appears to be an abandoned crossing. WS was to over grown with vegetation to access the area where the WS pump structure was previously found.4/6/2015 Same as last inspection. Crossing appears abandoned. Appears abandoned and if so should be done so properly. No Siphon breaker found on LS.6/30/2014 Same as last inspection.12/30/2013 Same as last inspection.7/29/2013 Same as last inspection. FIELD_STRUCT_DESC: *ABANDONED* 8-inch asphalt coated steel irrigation pipe through the levee, 4 feet below the crown. Pump on the waterside (WS) bank. Gate valve in a concrete pipe riser on the WS shoulder. (Permit No. 4091, 1962 - Halsey, Yerxa). [Additional Reference(s): DWR Levee Log, 2002]. FS Date: 4/26/2017 1:30:30 PM

Waterside view: abandoned pump station.

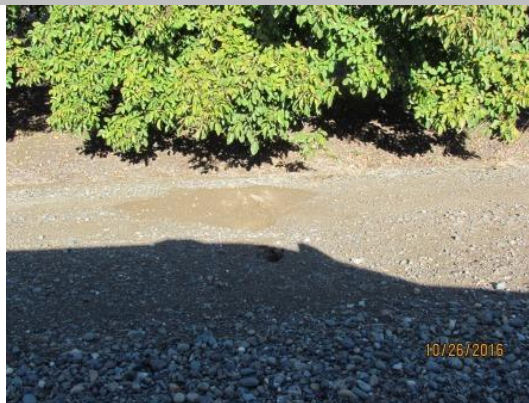
Photo 1 of 1 : SP_2017_ST0003_264_101_20170315_00031.jpg

LM Start	5.33	Rating **	M	Issue No.	101
LM End	5.33	Issue Type +	Ma	Location *	LS
Category	Earthen Levee			GPS Latitude/Longitude	
				Start	End
Item	Animal Control			39.216560 °	39.216560 °
				-122.002054 °	-122.002054 °
DWR ID	DWR_ST0003_01_f_2016_101				
Comment Code					
A3 : No rodents visible, but rodent burrows visible; need to backfill and compact or grout burrows.					
Inspector Comment

View of the rodent holes along the landside slope.

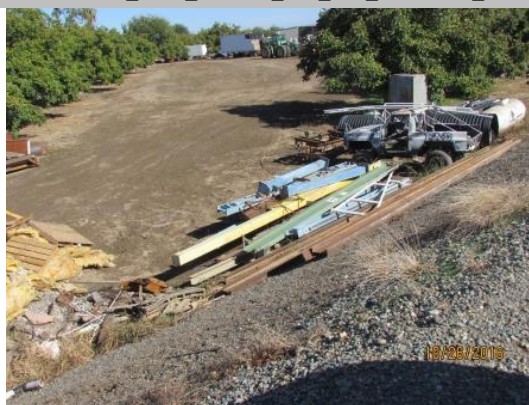
Photo 1 of 1 : SP_2017_ST0003_264_100_20170315_00030.jpg

LM Start	5.42	Rating **	M	Issue No.	100
LM End	5.42	Issue Type +	En	Location *	LS
Category	Earthen Levee			GPS Latitude/Longitude	
				Start	End
Item	Encroachments			39.217047 °	39.217047 °
				-122.003632 °	-122.003632 °
DWR ID	DWR_ST0003_01_f_2016_100				
Comment Code					
EQ : Equipment					
Inspector Comment

View of the ag equipment along the landside toe.

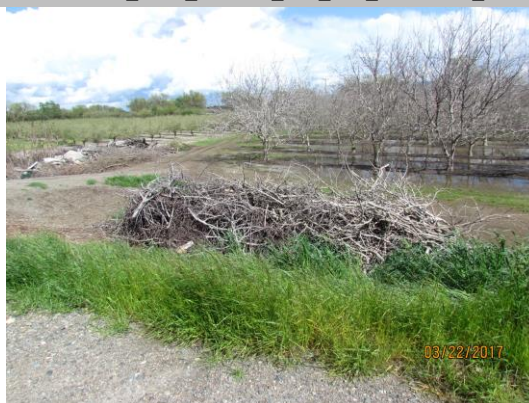
Photo 1 of 1 : SP_2017_ST0003_264_118_20170329_00183.jpg

LM Start	6.38	Rating **	M	Issue No.	118
LM End	6.38	Issue Type +	En	Location *	LS
Category	Earthen Levee			GPS Latitude/Longitude	
				Start	End
Item	Encroachments			39.223555 °	39.223555 °
				-121.999035 °	-121.999035 °
DWR ID	DWR_ST0003_01_s_2017_118				
Comment Code					
PR : Prunings					
Inspector Comment					
Remove the prunings from the landside toe.

View of the prunings at the landside toe.

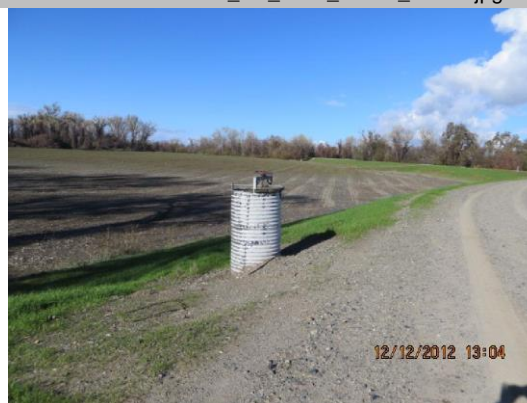
Photo 1 of 3 : UCIP_SP_2017_51688_47158.jpg

FS_ID:51688
DS_ID:17306
EP_NO: 9530
Repair Type: Non-Urgent
Crossing Status: Found
UCIP Comments: 4/16/2017 Abandoned- needs to be done properly.
(DWR Sutter Yard- AFreitag)10/31/2016 Appears abandoned. (DWR Sutter Yard- AFreitag)6/1/2016 Appears to be an abandoned crossing. WS end is about 90% buried with soil and the LS end is still unknown.4/1/2015 WS pipe end 3/4 blocked by soil. LS end is still unknown.Pipe outlet on WS partially burried, it needs cleaning.6/30/2014 Same as last inspection.12/18/2013 Same as last inspection.7/23/2013 Same as last inspection
FIELD_STRUCT_DESC: *ABANDONED* 30-inch corrugated metal drainage pipe through the levee, 15 feet below the crown. Slide gate in a corrugated metal pipe (CMP) riser on the waterside (WS) slope. (Automatic Board Order (ABO) issued as Permit No. 9530, 1974 - Halsey). [Additional Reference(s): DWR Levee Log, 2002].
FS Date: 4/26/2017 1:45:14 PM

LM Start	6.40	Rating **	M	Issue No.	152 (cont)
LM End	6.40	Issue Type +	En	Location *	LS

Waterside view: CMP riser with slide gate

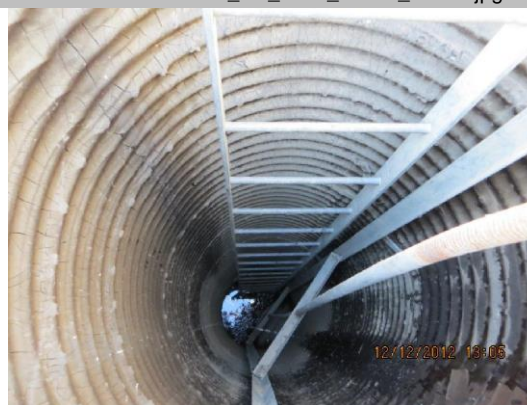
Photo 2 of 3 : UCIP_SP_2017_51688_47156.jpg

Waterside view: inside CMP riser
